Electrical safety and safety standards for PV installations represent a particular challenge for the operator

Operating photovoltaic installations safely and efficiently

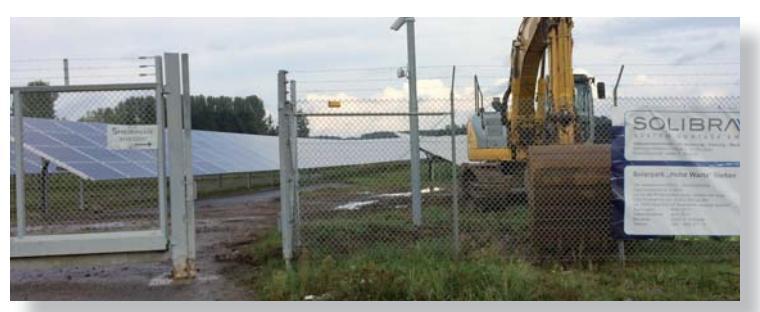
The door is open to the solar field, anybody can walk in

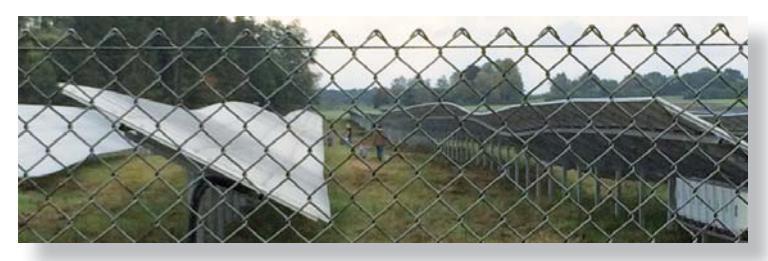
Unauthorised people (family with children) are walking around in the solar field without knowing the dangers lurking around.

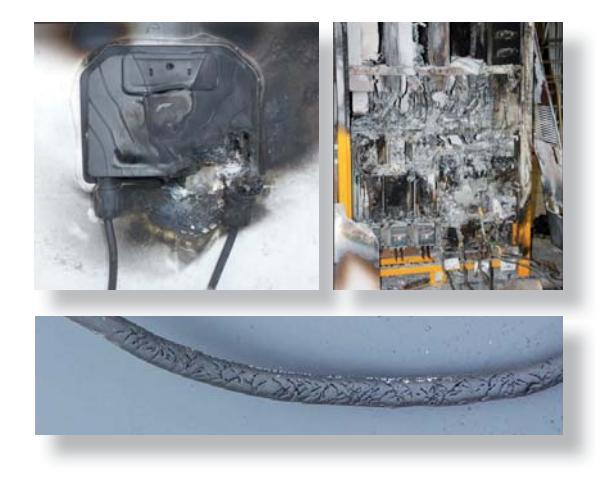
In relation to "rodent damage" the following is stated in the book "Brandschutz in elektrischen Anlagen" by Herbert Schmolke: Such insulation damage is often not even detected by an insulation resistance measurement, as the remaining air gap between the bare conductors is very high impedance. As such the instrument sees intact insulation. Only on the addition of atmospheric humidity, soiling or the like do hazardous creepage currents occur.
